**THE CASE OF THE UNINTENTIONAL PILOT LIGHT**

We've all heard the old maxim: "Every cloud has a silver lining." Most of us wouldn't associate this saying with the devastating effects of a house fire. Coming home to a house filled with smoke is a fear shared by every homeowner. However, as shown in this issue's case study, there are times when even a small fire can prevent a much larger disaster.

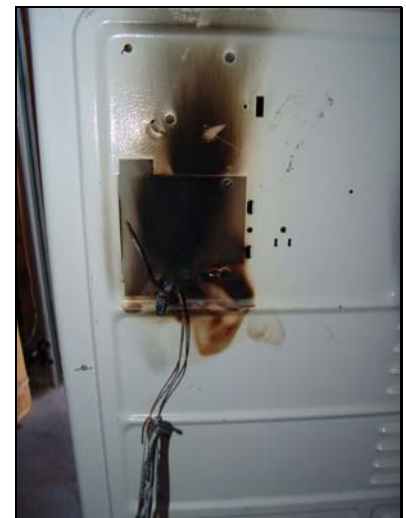
Figure 1

We were hired by the homeowner's insurance company to investigate the fire and determine what role, if any, the home's gas system and clothes dryer played in the cause of the fire. As shown in Figures 1 & 2, the fire damage was extremely limited. A small burn pattern on the half-wall behind the dryer was punched in by the fire department during their investigation. The dryer sustained damage near the power cord entrance.

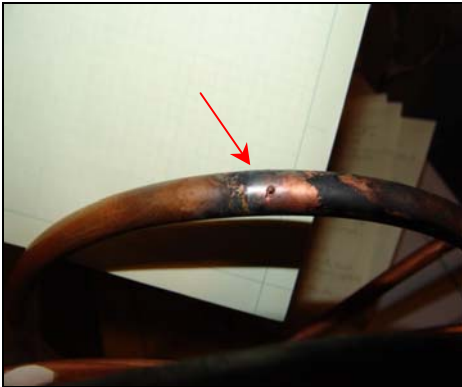
Figure 3

Curiously, in this case, the other two conductors were not damaged; only the hot conductor sustained melting and arcing. So what caused the damage to the power cord? The answer was revealed upon closer inspection of the natural gas line traveling to the dryer. A small irregular-shaped pinhole was found in the wall of the copper pipe, shown in Figure 3.

The copper gas line to the clothes dryer ran up from a local valve in the utility room, ran across the ceiling, and traveled down the opposite wall to the dryer. At this point, the original installer apparently took the extra piping and wrapped it into a three-loop coil. The coiled piping was wedged between the dryer and wall. The location of the electrical receptacle behind and to the left of the dryer required the power cord to stretch tightly along the wall. Measurements of the power cord along with the location of the dryer showed that the cord must have touched or ran through the coils of gas piping.

As the dryer shifted around during operation, or when pulled away from the wall, the power cord eventually became wedged between the coils of gas piping. Over time the cord insulation wore away due to vibration and compression. Eventually the hot conductor contacted and arced to the grounded copper gas line. The arcing produced intense heat that ignited the power cord insulation. It also ignited the gas seeping out of the newly formed pinhole in the gas line. This created a small sustaining flame, much like the pilot light on a water heater.
